Monitoring Data Record

Project Title: R-2000G (I-540) COE Action ID: 199920387

Stream Name: UT Neuse River (Site 10) DWQ Number: 030114

City, County and other Location Information: I-540, Wake County (Sta.460+53 -L- to 459+80 -L- RT.)

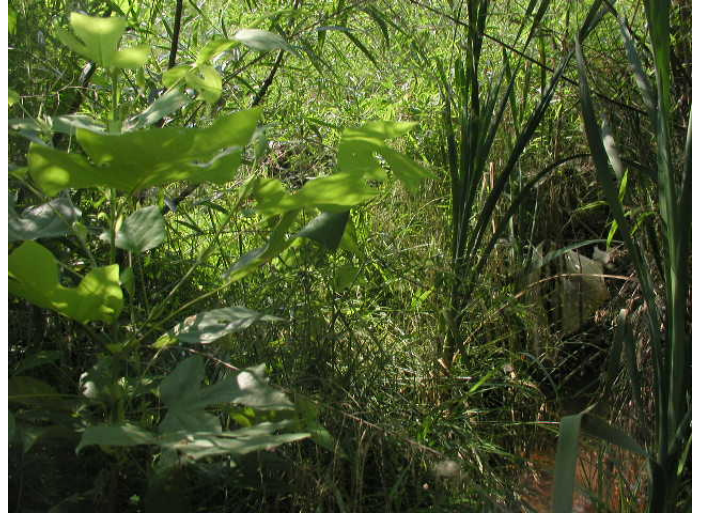
Photo Point #1 (Upstream Looking at Culvert)

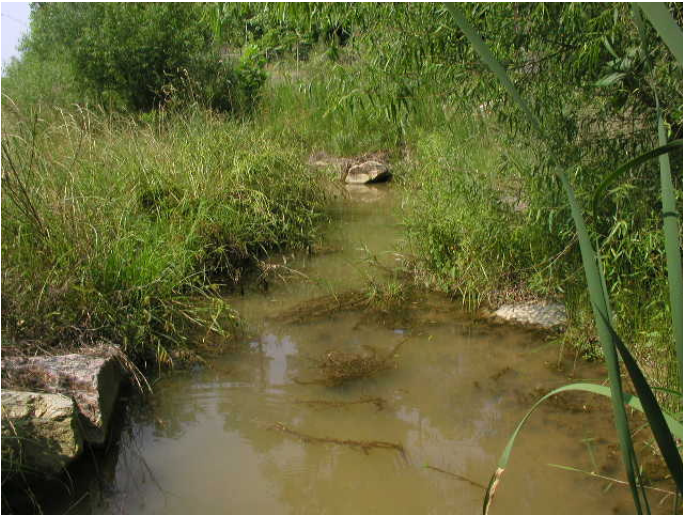
Photo Point #4 (Upstream)

An automobile accident occurred in June 2007 on I-540, which is adjacent to this stream relocation. The accident site carried over the guardrail and into the stream relocation area. Since, the accident has occurred steps have been taking to seed and mulch the area that was disturbed. Photo Point #4 upstream shows the stream relocation area where the accident occurred.

Estimated causes, and proposed/required remedial action: This area was replanted with bareroot seedlings and some additional live staking also took place.

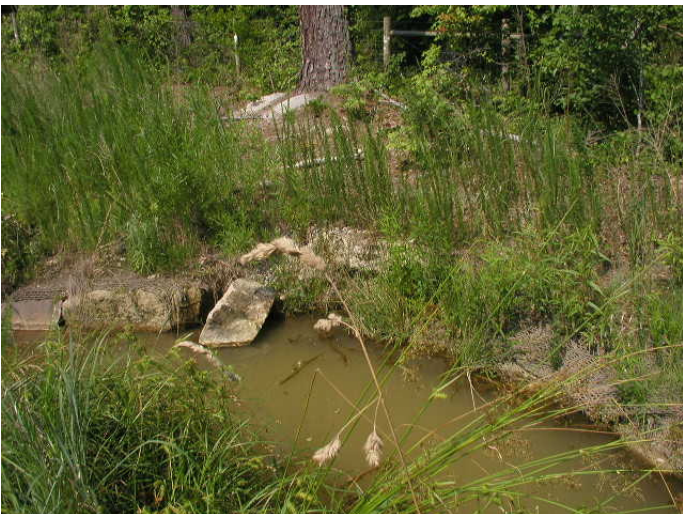
The stream is stable for the Year 2 Summer Evaluation. The previous bank erosion at the end of a crossvane arm @ Sta. 460+00-L- is stable at this time. Some additional live staking took place in this area to help stabilize the left streambank. Debris was deposited onto floodplain which indicates a bankfull event has occurred since the last monitoring evaluation. NCDOT will continue to monitor this stream relocation

7/16/07	Sta. 460+00	Station Number	Station Number	Station Number	Station Number
Structure Type	Cross vane				
Is water piping through or around structure?					
Head cut or down cut present?					
Bank or scour erosion present?	Minor bank erosion at the end of cross vane arm				
Other problems noted?

Bank erosion on left bank at the end of a cross vane arm @ Sta. 460+00
Year 2 Summer – June 2008
